ACOUSTIC EMISSION MONITORING OF SMALL WIND TURBINE BLADES

P.A. Joosse¹, M.J. Blanch², A.G. Dutton², D.A. Kouroussis³, T. P. Philippidis⁴, P.S. Vionis⁵

Wind turbine blade certification tests, comprising a static test, a fatigue test, and finally a residual strength test, often involve sudden audible cracking sounds from somewhere within the blade, without the operators being able to locate the noise source, or to determine whether damage (minor or major) has occurred. A current EC-funded research project is looking at the possibility of using acoustic emission (AE) monitoring during testing of fibre composite blades to detect such events and assess the blade condition. AE can both locate and characterise damage processes in blades, starting with non-audible signals occurring due to damage propagation at relatively low loads. The test methodology is discussed in the context of the blade certification procedure and results are presented from a series of static and fatigue blade tests to failure in the laboratory. Inferences are drawn about small differences in the manufacture of the nominally identical blades and conclusions are presented for the application of the methodology.

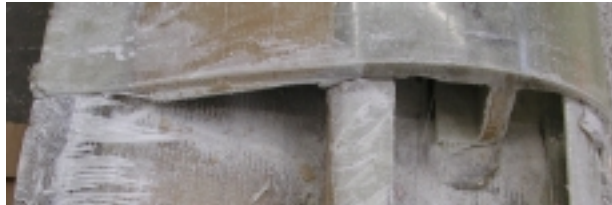
figure 2: Inside view of blade (post mortem)

The first four blades were manufactured with short shear webs (0.8-2.1 m radius) in order to ensure that AE activity would occur by buckling in a predictable region of the blade. The next two blades (5 and 6) were designed to meet the IEC-61400-1 standard, shear webs running to 3.1 m radius.

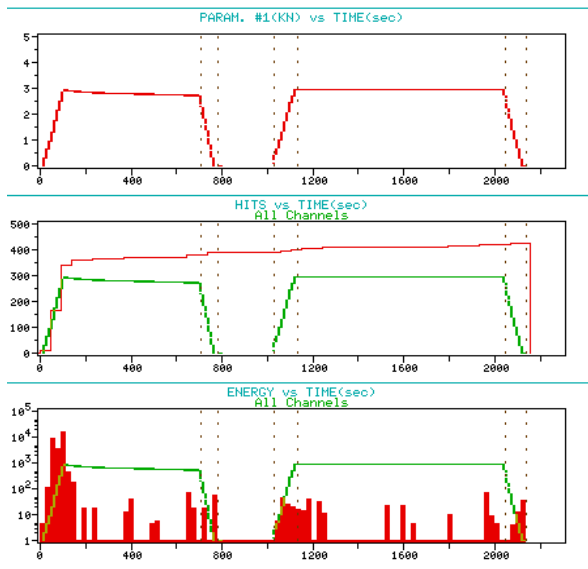
figure 4 : Initial loading of virgin blade 1 to OL and repeat - load profile (top); cumulative AE hits (centre); AE signal energy (bottom)

Figure 4 shows the typical burst of AE activity associated with the first loading to a given load level and the much quieter repeated loading. Based on the absence of significant load-hold activity, it was assessed that both blades could withstand the test load (3 kN). This was verified, since the blade failed in buckling at 7 kN.

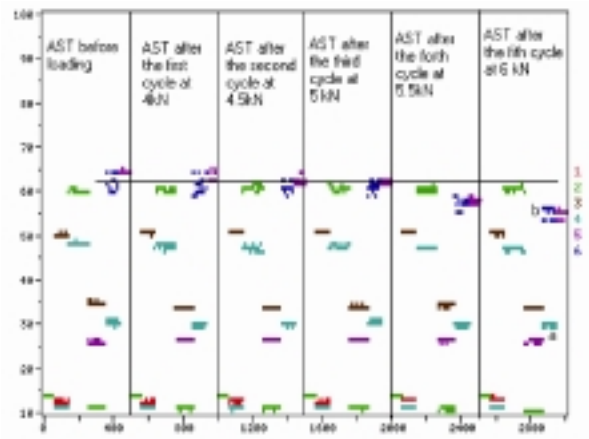
figure 6: AST energy at receiving channel at start of test and after each load-hold cycle (blade 2)

In the Auto Sensor Test (AST), the energy at the receiving channel is plotted against hit number (figure 6). All signals remain at essentially the same level, except for transmission between sensors 5 and 6, which

drops markedly after the 5.5 kN load-cycle and further still after blade failure (marked b). The transmission received at sensor 4 from sensor 5 (marked a) remains consistent. For these tests therefore, it can be concluded that changes detected in the AST indicate a meaningful change in the blade.

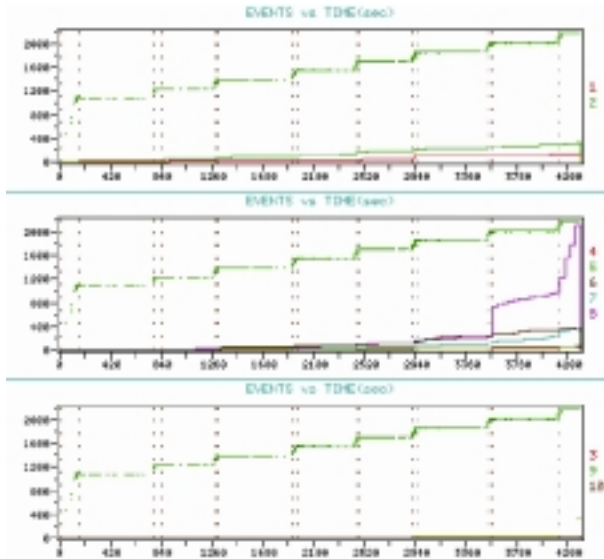
figure 8: Comparison of step load tests to failure on blade 1

Figure 8 shows events v time during the step load tests to failure. (An event is defined as the first hit of one or more hits caused by one single AE occurrence, i.e. the hit corresponding to the sensor that first detected this AE.) The test load is shown superimposed on the upper trace. From the graph it can be seen that AE activity increases significantly as the load level increases. On the load-hold prior to failure, AE is continuous and does not stabilize at the sensors nearest the final failure points (sensor 8). This is a clear indication of progressing damage during the load-hold and is characteristic of impending failure. The activity at the critical channels (i.e. number of events) is higher than on the other channels.

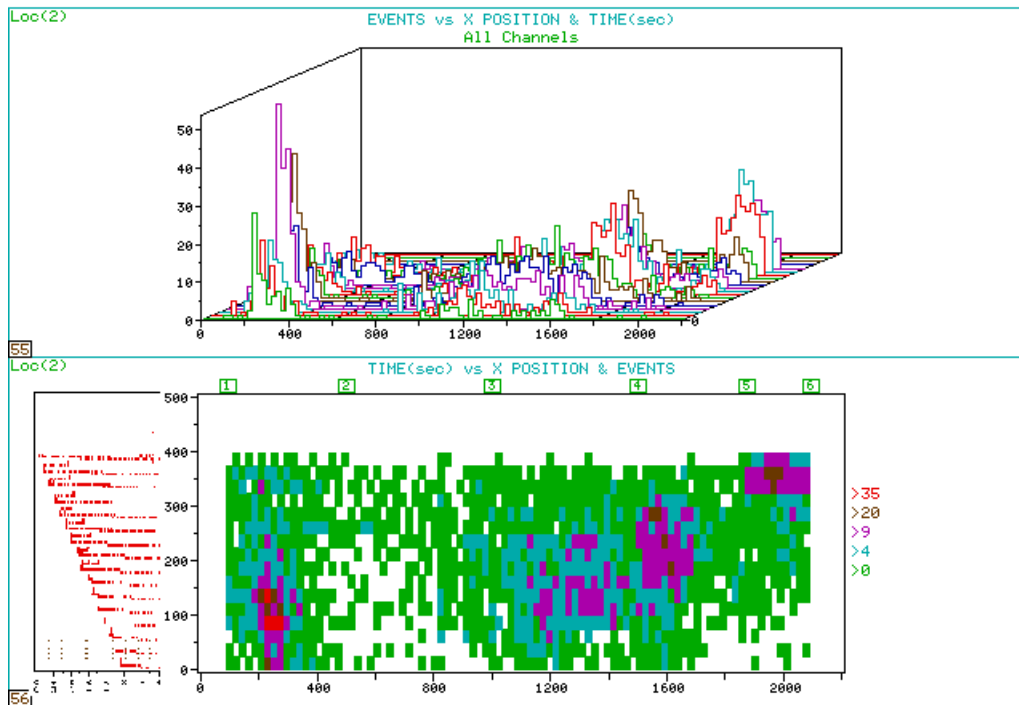
figure 10: Damage progression by linear location for sequence of MTL tests in terms of AE signal energy by position (x-axis) and time (z-axis - top; y-axis - bottom) with applied load inset

Results are presented in terms of number of located events for a typical static blade test in figure 10 and figure 11. A large number of events are generated in the root at an early stage in the test; this was typical of all the blades tested and may be partly attributable to the transition between steel and GRP parts. Minor visible damage did develop in the root area, but the major failure occurred at a radius of about 2.0 m, where the second large events peak is located.

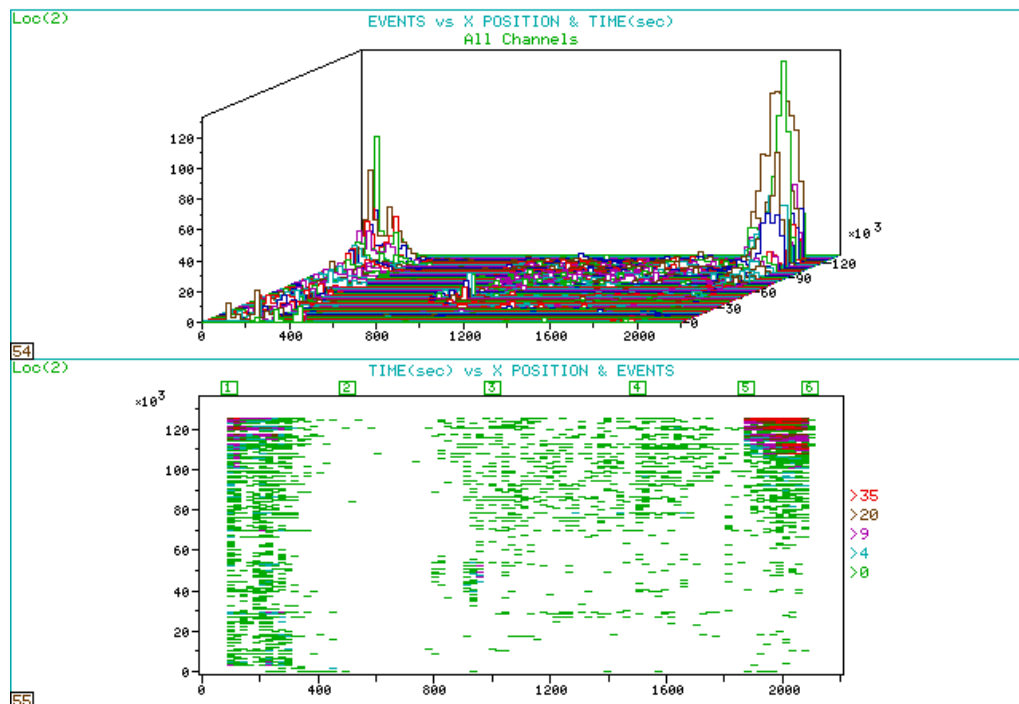
figure 11: Damage progression by linear location for sequence of EL tests in terms of AE signal energy by position (x-axis) and time (z-axis - top; y-axis - bottom)

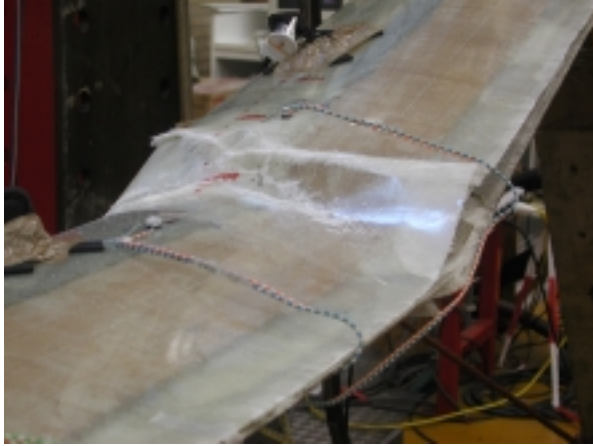
figure 12: Blade fractured in static loading at the defect zone

Damage growth and final failure occurred at the defect zones. For blade 9 the delaminated shear web clearly caused the final failure, as can be seen in figure 12. Damage growth could not be observed visually, but the AE data indicate that the location of the AE events move during the test. A defect at the trailing edge showed some crack growth, which stabilised during the test.

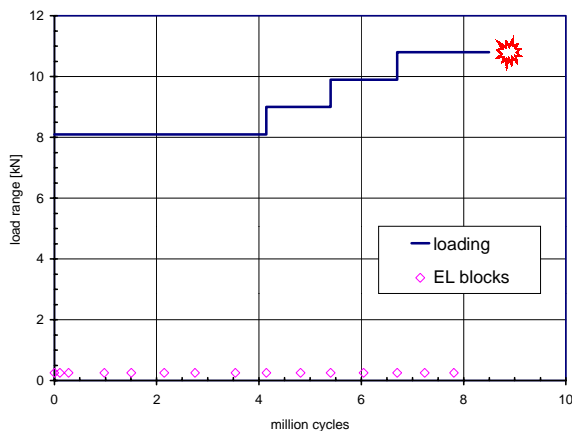
figure 13: Idealised load history of blade 6

gradual increasing damage, to be monitored by the AE system, in a limited time. The fatigue load has been increased in steps to realise failure, since the actual strain levels and material fatigue behaviour are not known correctly. As an example, the idealised fatigue spectrum for blade 6 is shown in figure 13.

For the evaluation of the fatigue tests, information from the static load blocks (labelled 'EL-blocks' in figure 13) can be used, or from the slow cycles, recorded every 10,000 cycles.

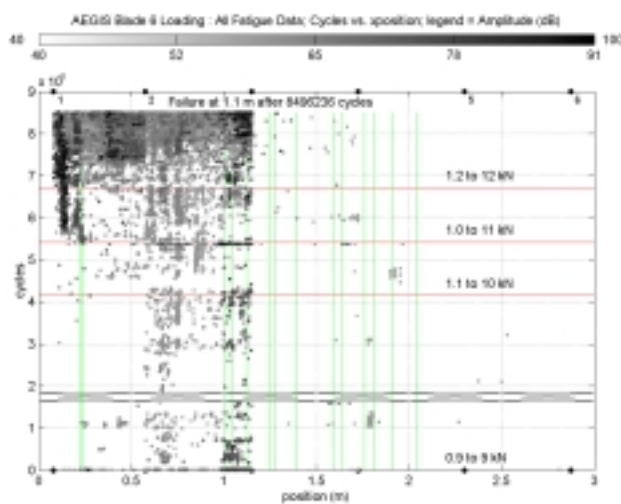
figure 16: Amplitude history of linearly located events during slow cycles for blade 6

A typical presentation of results showing the amplitude data for blade 6 is plotted in figure 16. A cluster of high amplitude events can be seen at the 1.1 m failure point.

Other clusters of high amplitude events occur at 0.1-0.2 m in the root and at 0.4 m. figure 16 also shows the nominal location of other cracks (vertical lines) which appeared in the sandwich part of the blade at various stages of the test. Many of these are not well located by high amplitude (or high energy) events and require further investigation. Clearly, the number and severity of high amplitude events must be assessed in relation to the blade strength distribution to decide on the criticality of particular AE behaviour. This is the role of the Pattern Recognition software, which will now be used to carry out a multivariate assessment of the results and hence grade the criticality of damage found during the test.

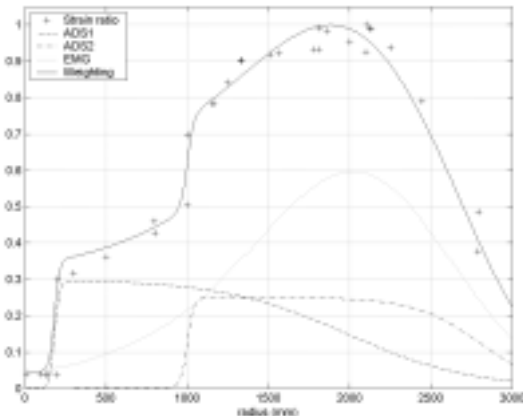
figure 17: Derivation of the Strain Weighting curve fit for blades 2 and 3.

As a first step filtering has been done on the calculated maximum strain level at the location, for the external load. For this approach it is assumed that only normal strains are important. The Strain Weighting curve-fit is given in figure 17 and shows that the highest strains are expected to occur at 1.8 m.

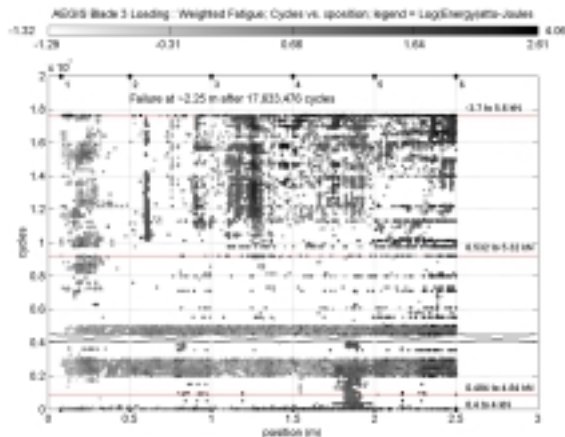
figure 19: Linear location of AE Energy during the fatigue test (filtered data)

The result of using the Strain Weighting as a multiplication factor is shown in figure 19. The filtering concentrates the high emission in the area of failure. This is despite the fact that the emission in the failure area itself was reduced relatively to inboard sections by the weighting. At the bolt ends the emissions have almost completely disappeared. High energy activity can still be observed at 1.25 and 1.45 m radius, but not clustered to the same degree as for the failure area.
